# Environmental Impact Assessment Report

Derrybrien Wind Farm Development  
Decommissioning Project –  
Prospective Development

Volume 2a: EIAR Appendices  
2-1 to 8-1

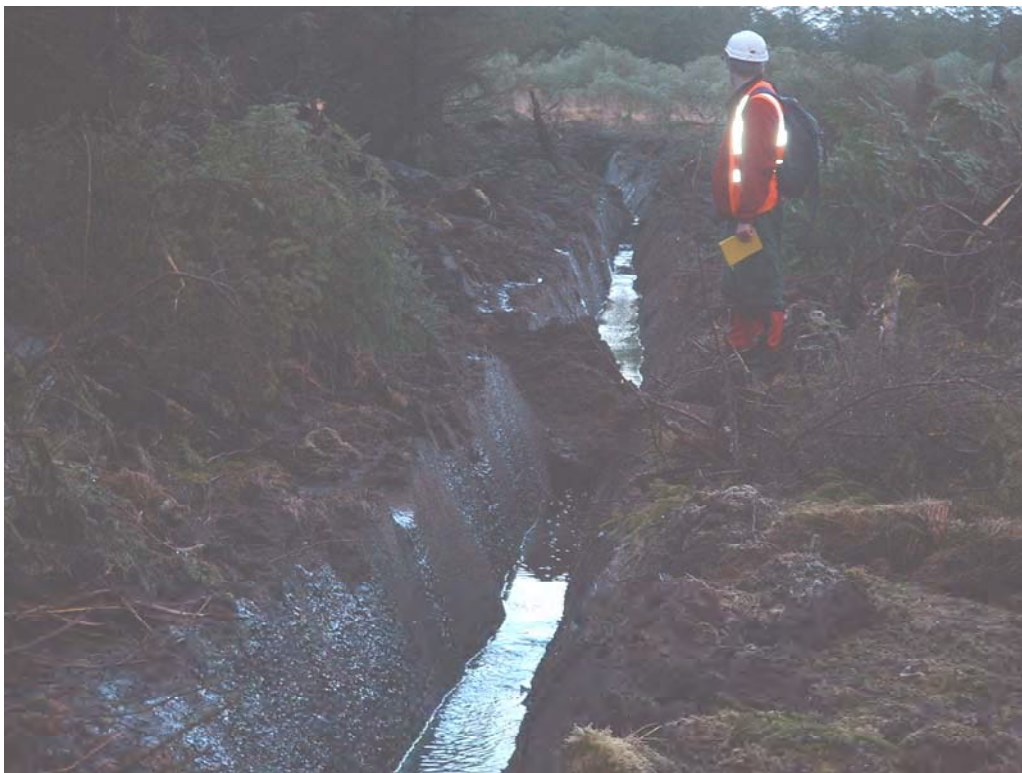
**T14 – Collapsed Drain.**

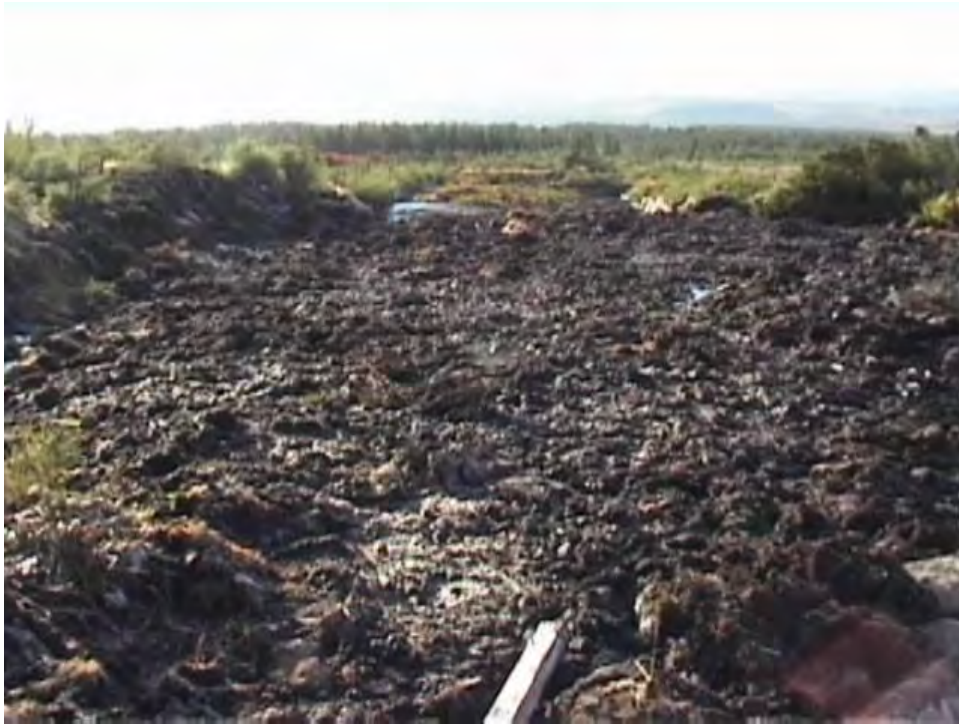
**T17 - East of Turbine Base Looking Downslope of Failure.**

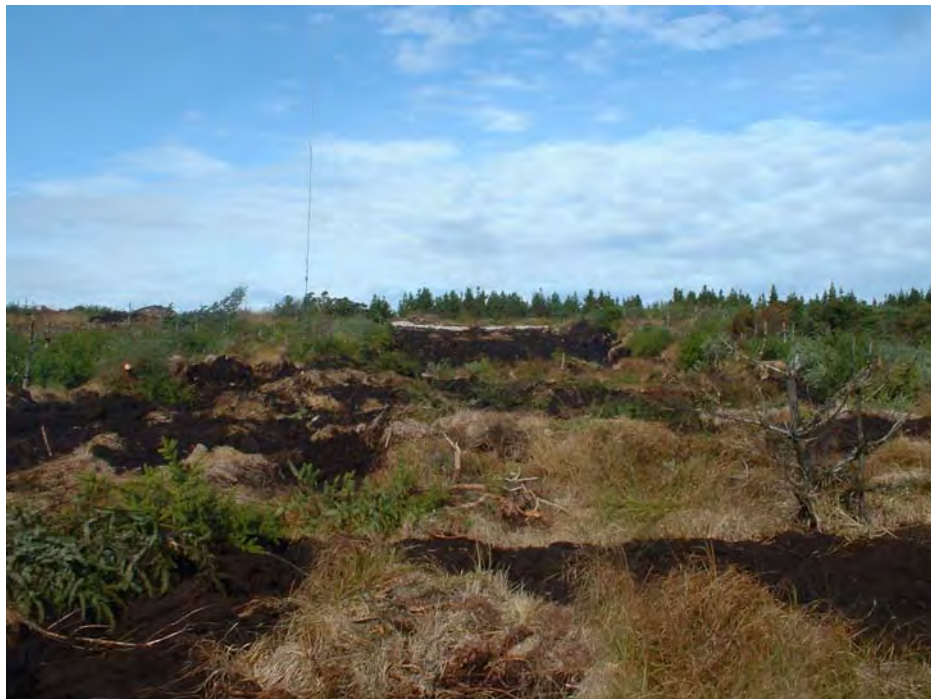
**T17 - South of Failure Looking upslope**

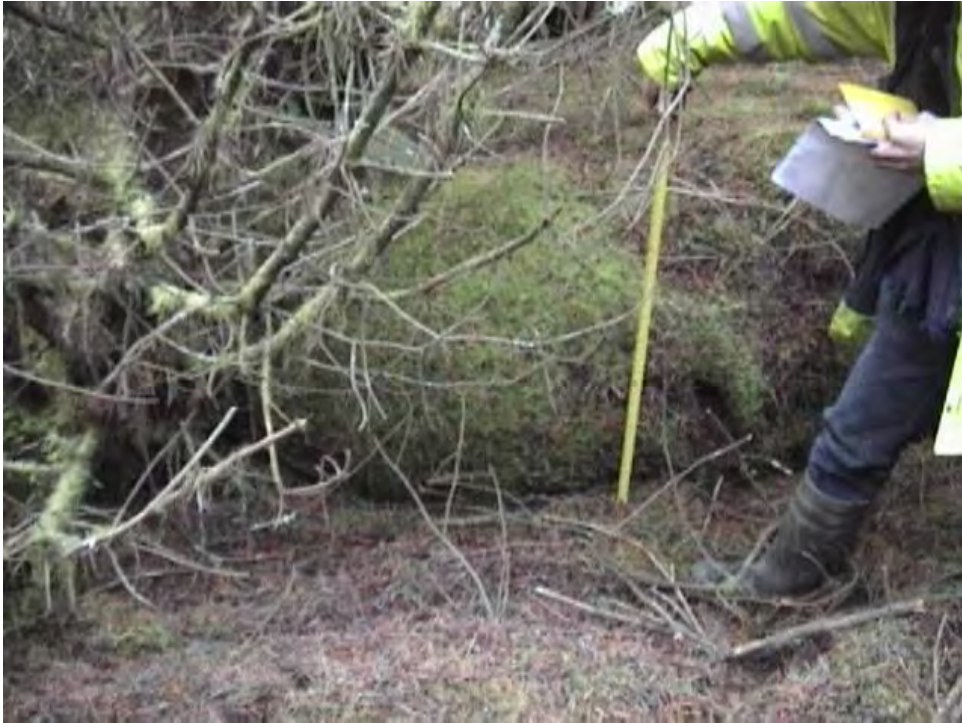
**T29 – Bearing Failure South of Access Road and Arisings.**

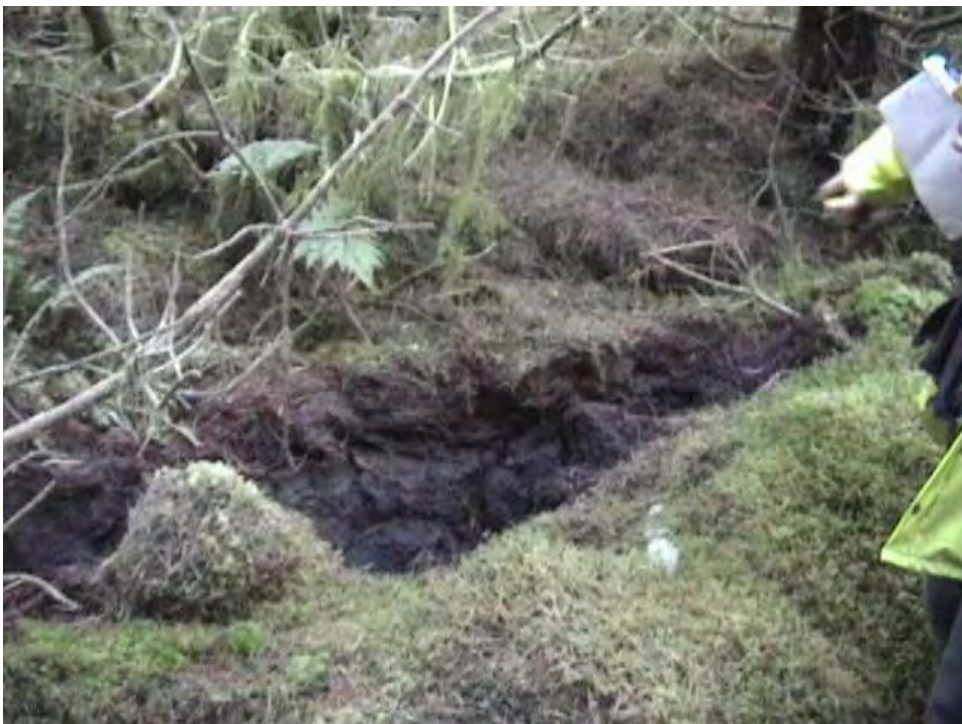
**T29 – Tension Crack at Tree Line**

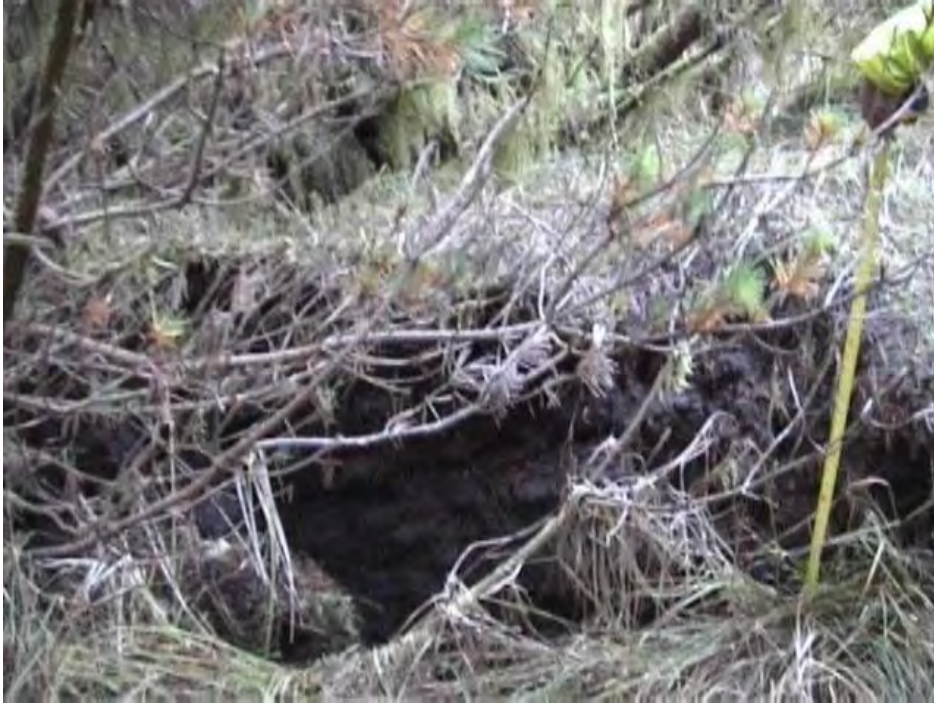
**T66 – Heave of Intact Peat.**

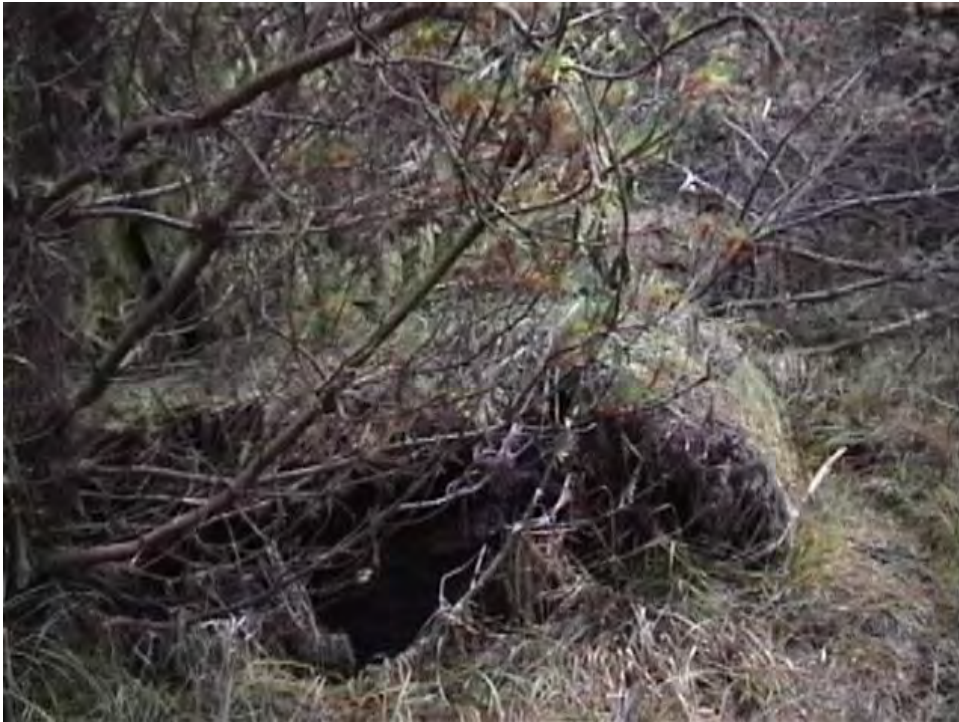
**T66 – Bearing Failure South of Access Road and Arisings.**

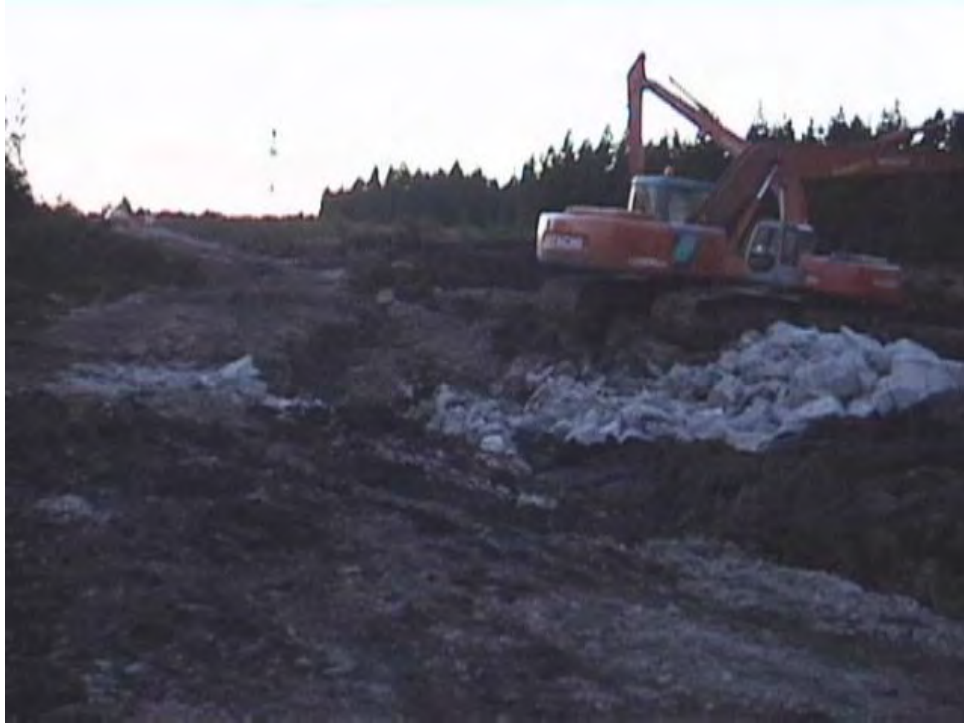
**T68 – Crest of Failure, Bowing of Access Road.**

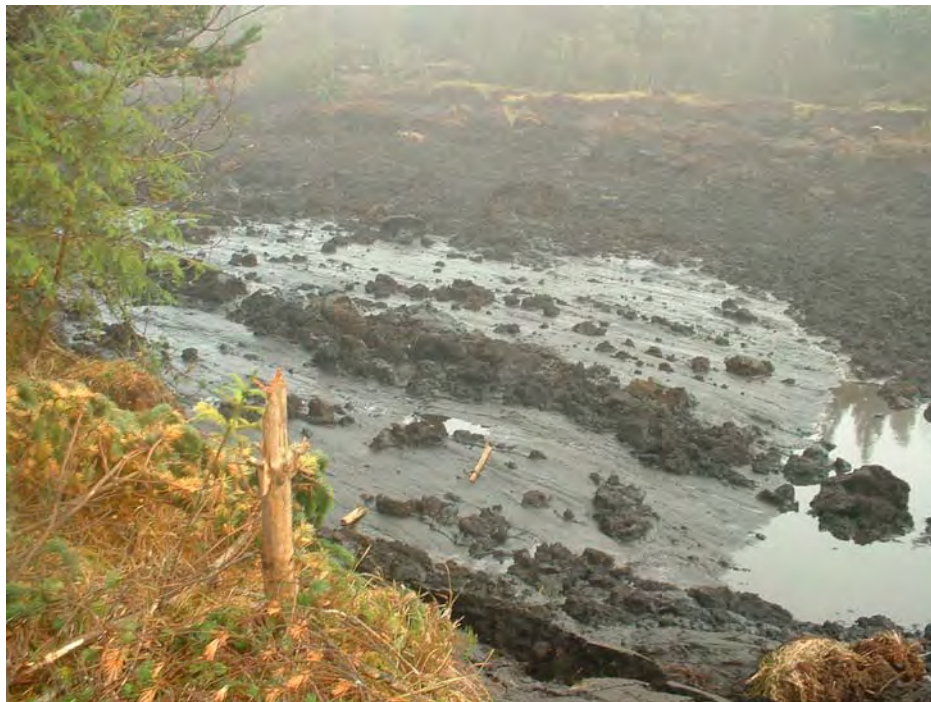
**T68 – Failure Plane Approximately 50m South of Base.**

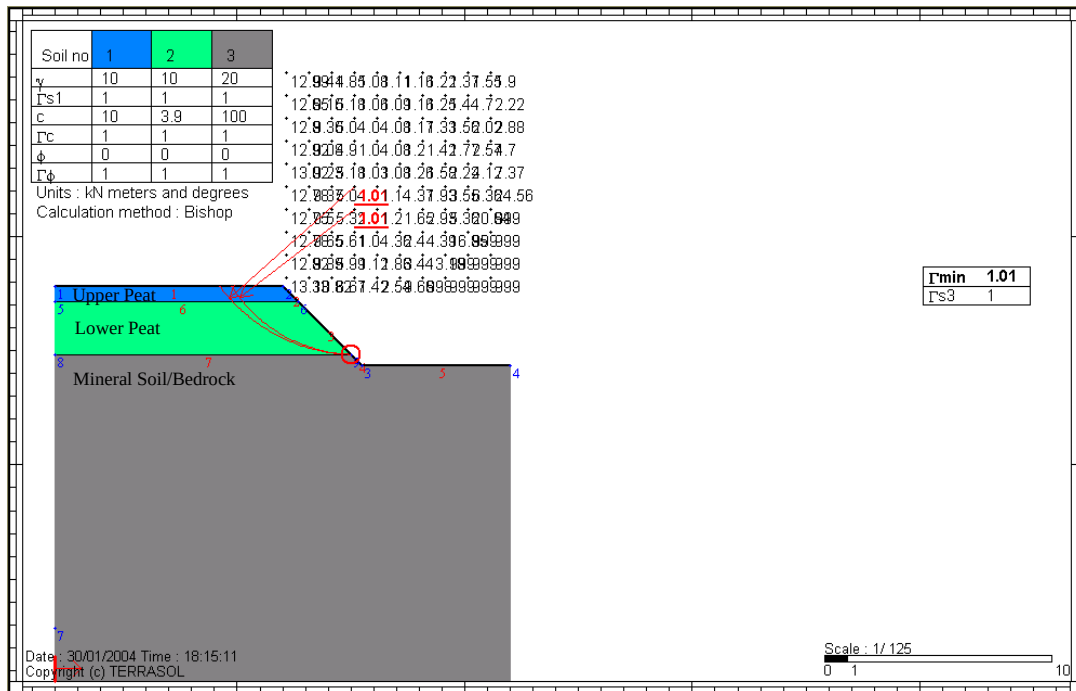
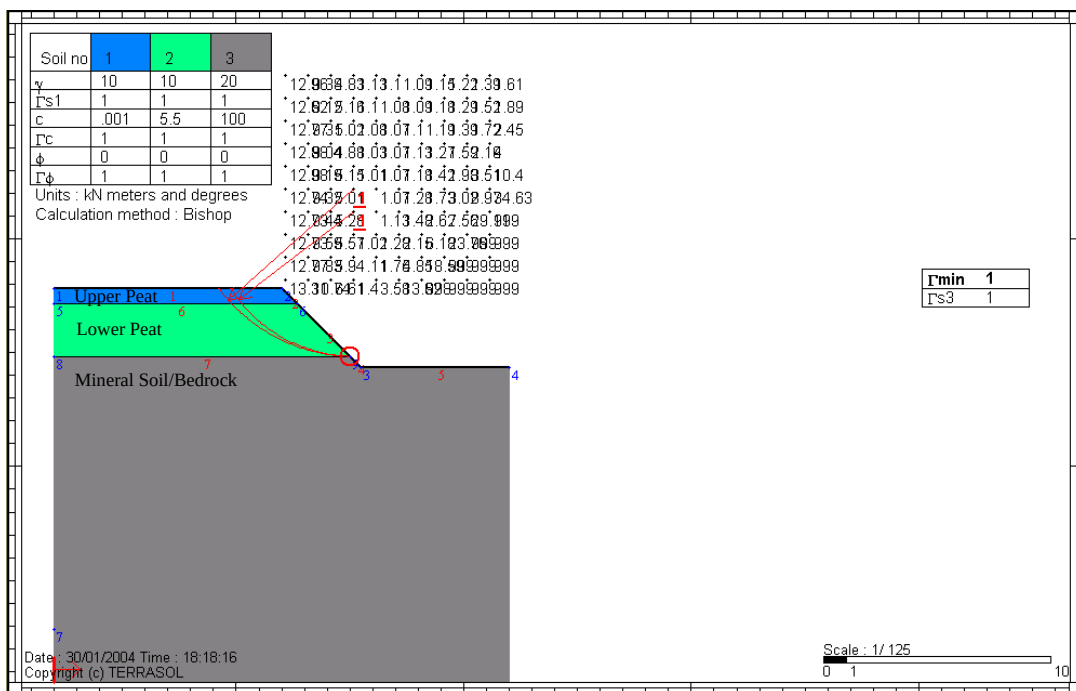
(a) Analysis with intact upper peat

(b) Analysis with upper peat assumed to be cracked

Figure: Back-analysis of Side-wall Failure of Turbine Base Excavations
