# Environmental Impact Assessment Report

Derrybrien Wind Farm Development  
Decommissioning Project –  
Prospective Development

Volume 2a: EIAR Appendices  
2-1 to 8-1

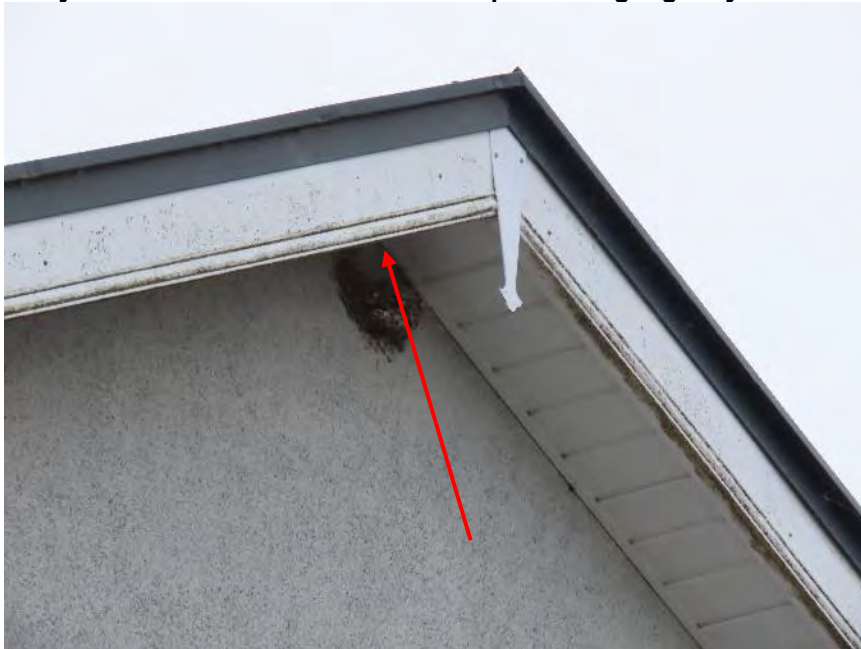
| Roost ref. | Bat roost evidence and interpretation | Roost type <sup>1</sup> | Conservation significance | Consideration of seasonal use |
|---|---|---|---|---|
| R1 | Common pipistrelle bat: one bat recorded during two of the four survey occasions (15/08/22 and 20/07/23) roosting in a small crevice at the gable apex on the eastern elevation of the building (Photograph 4). Roost likely used by non-breeding individual / small numbers of bats on an occasional basis. | Day | Low | Occasional use throughout active season. Low suitability for hibernation. |

**Photograph 4: Roost R1 (common pipistrelle day roost) location at Derrybrien Substation. The bat access point is highlighted by the red arrow.**

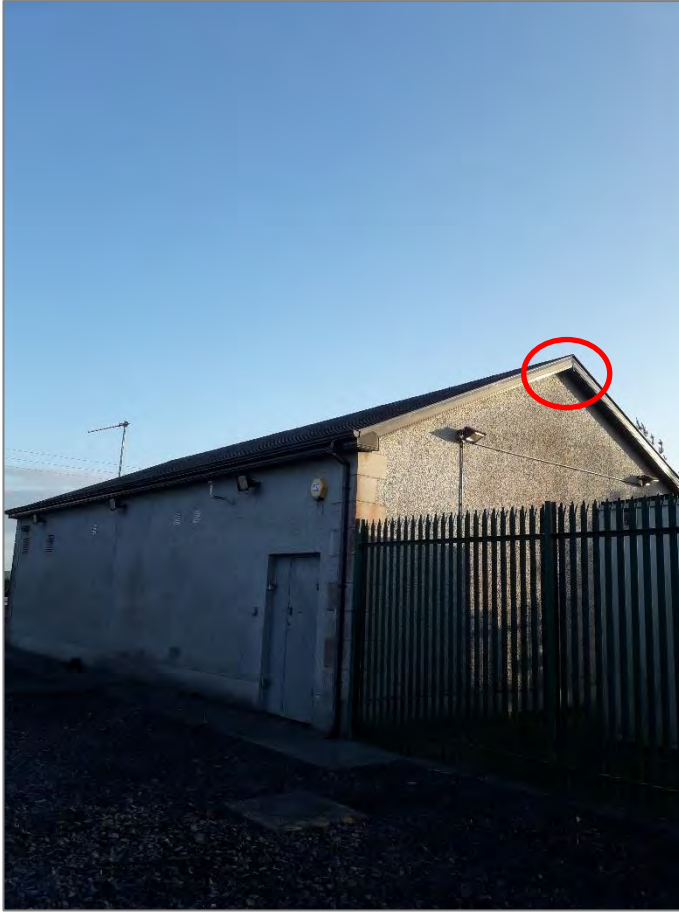
| Roost ref. | Bat roost evidence and interpretation | Roost type <sup>1</sup> | Conservation significance | Consideration of seasonal use |
|---|---|---|---|---|
| R2 | Common pipistrelle bat: between two and seven bats recorded roosting in this location during each of the three nocturnal surveys. The roost location is in a small crevice at the gable apex on the northern elevation of the building (Photograph 5). Roost likely used by non-breeding individual / small numbers of bats on an occasional basis. | Day | Low | Occasional use throughout active season. Low suitability for hibernation. |

**Photograph 5: Agannygal Substation building (north elevation). Roost R2 (common pipistrelle day roost) location circled red.**

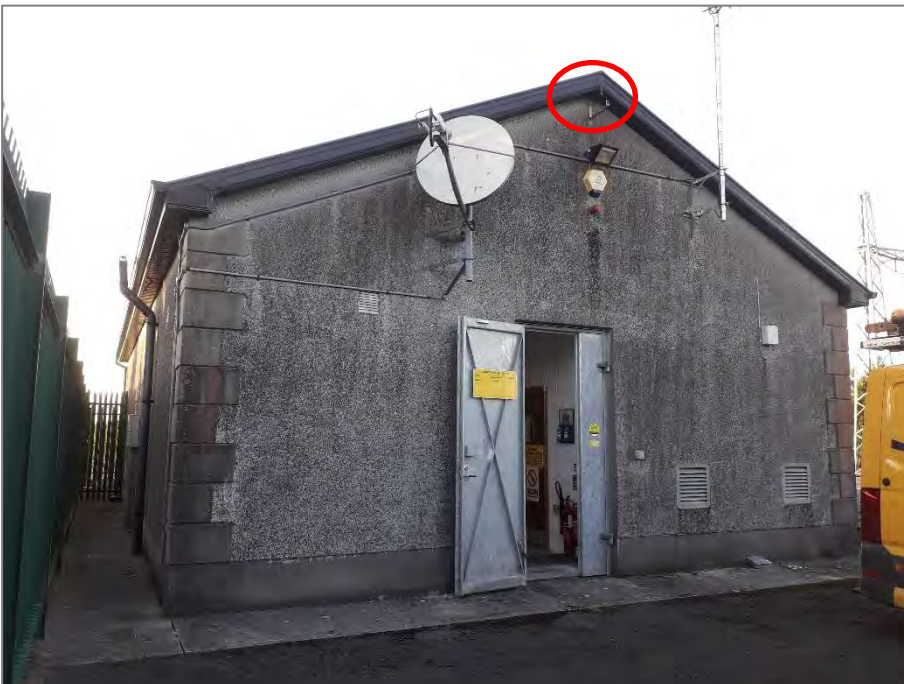
| Roost ref. | Bat roost evidence and interpretation | Roost type <sup>1</sup> | Conservation significance | Consideration of seasonal use |
|---|---|---|---|---|
| R3 | Common pipistrelle: three bats recorded roosting during one of the three survey occasions (08/09/22) in a gap at the gable apex on the southern elevation of the building (Photograph 6). Likely used by individual / small numbers of bats on an occasional basis. | Day | Low | Occasional use throughout active season. Low suitability for hibernation. |
| | Soprano pipistrelle: one bat recorded roosting during one of the three survey occasions (19/07/23) in a gap at the gable apex on the southern elevation of the building (Photograph 6). Likely used by individual / small numbers of bats on an occasional basis. | Day | Low | Occasional use throughout active season. Low suitability for hibernation. |

**Photograph 6: Agannygal Substation building (south elevation). Roost R3 (common pipistrelle and soprano pipistrelle day roosts) location circled red.**

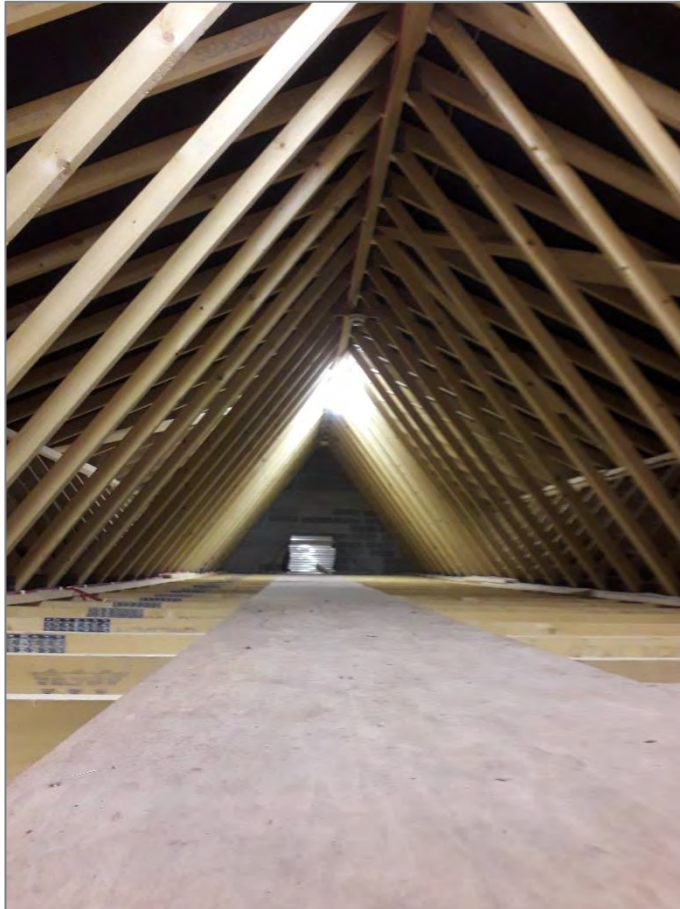
| Roost ref. | Bat roost evidence and interpretation | Roost type <sup>1</sup> | Conservation significance | Consideration of seasonal use |
|---|---|---|---|---|
| R4 | Brown long-eared bat: 10-15 brown long-eared bat droppings recorded within the loft void (Photograph 7) of the building (confirmed by DNA analysis). No brown long-eared bats recorded roosting during nocturnal surveys. Likely used by individual / small numbers of bats on an occasional basis. | Day | Low | Occasional use throughout active season. Low suitability for hibernation. |

**Photograph 7: Loft space within the Agannygal Substation building. Roost R4 (brown long eared and common pipistrelle day roosts) are present within the loft.**

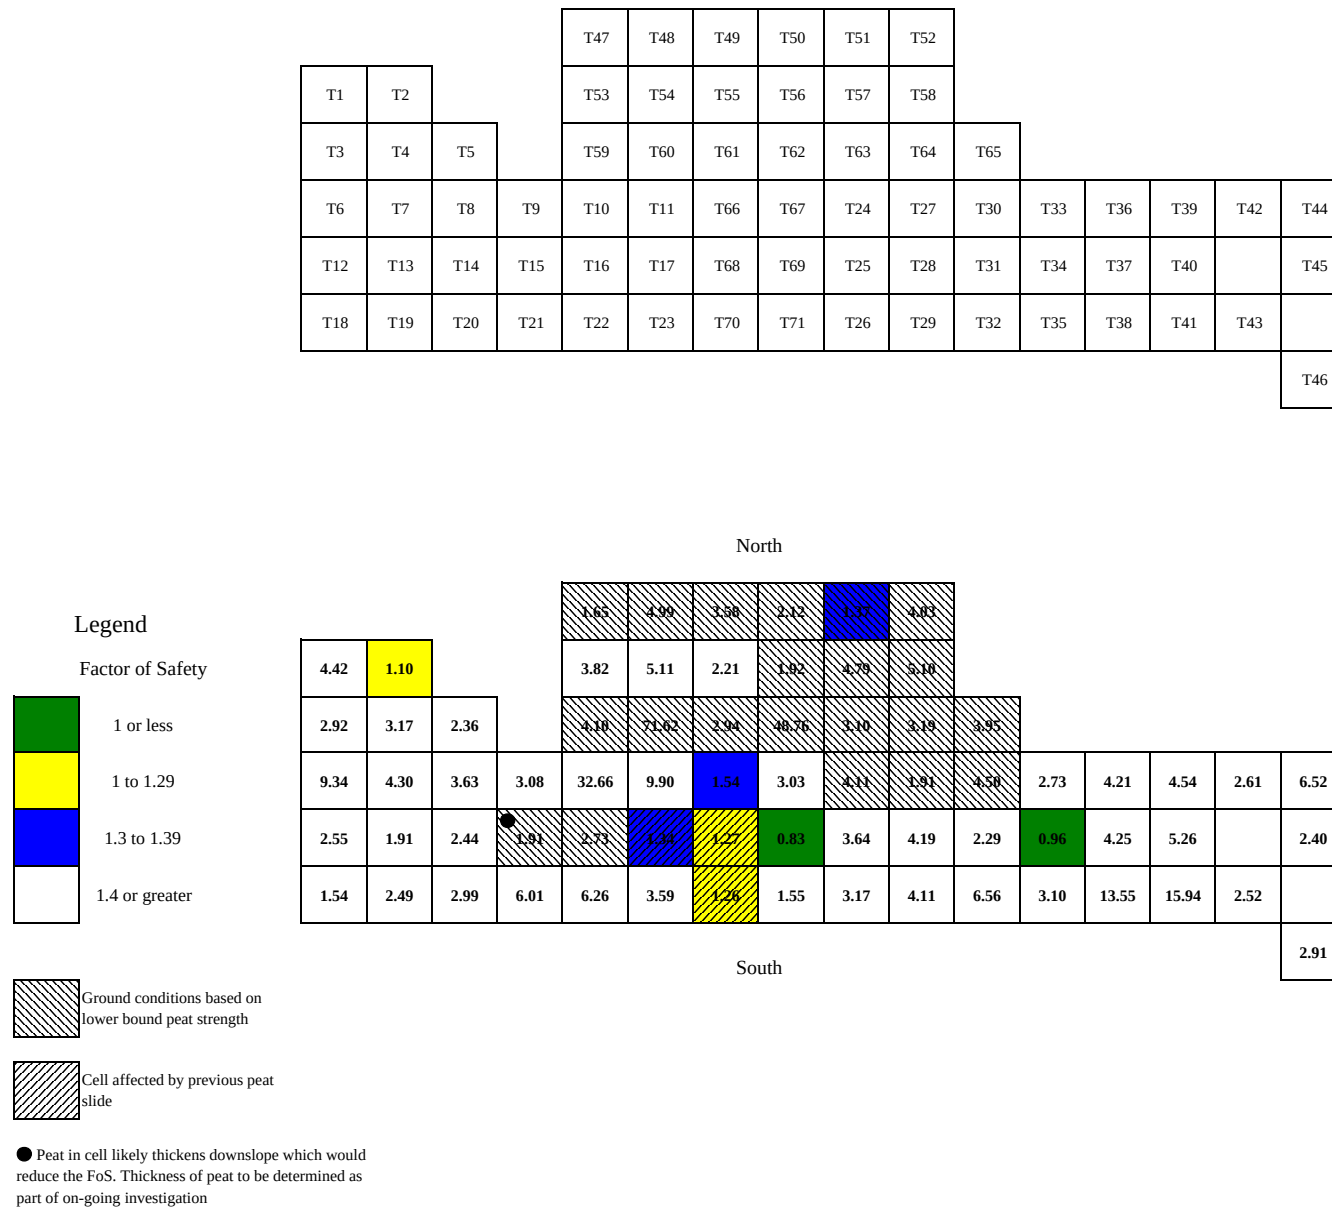
Figure 10 Factor of Safety for 50m Cell under Load Condition (1)

- (13) Results of stability assessment for 50m cells (Figure 10) show that the existing stability of the peat slope in the vicinity of the turbine base is above FoS of 1.4, except for the following 4 cells, namely t2, t34, t51 and t69. This excludes cells that have already been affected by sliding failure.

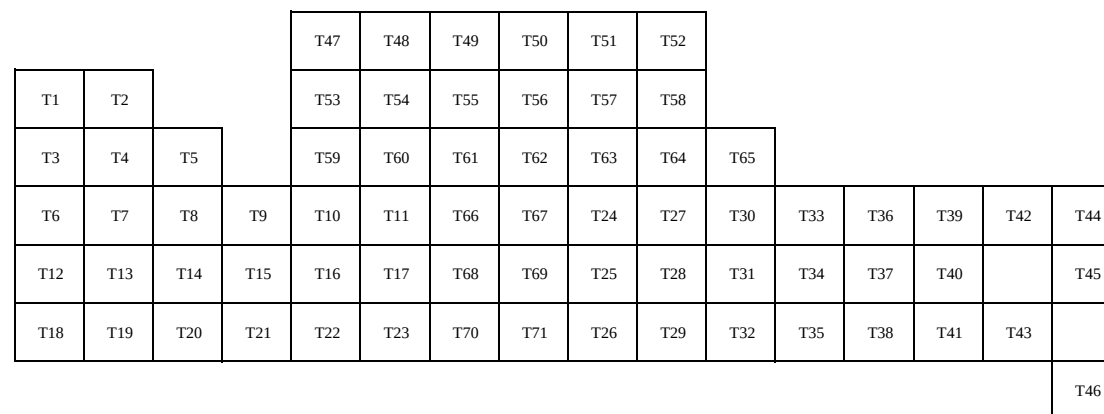
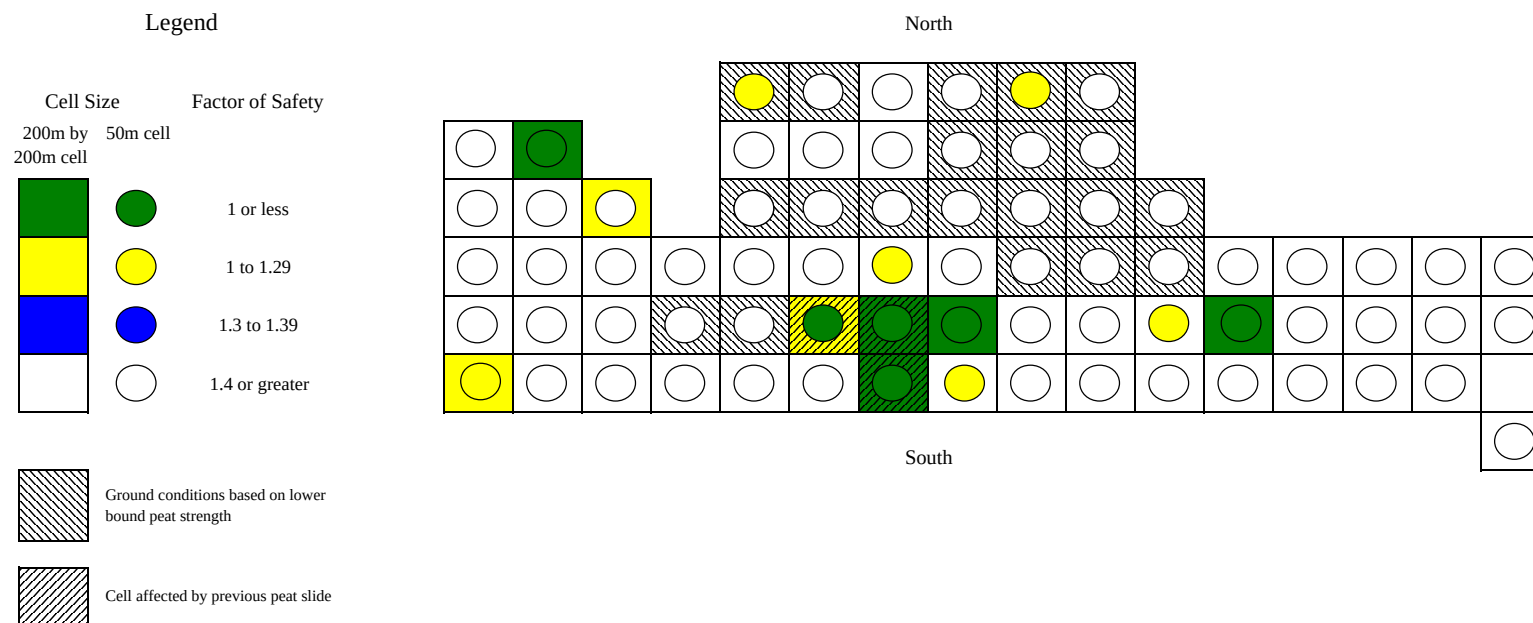
Figure 12 Summary of Factor of Safety for 200m by 200m and 50m Cells under Load Condition (2)

- (15) Comparison of FoS results between 200m by 200m and 50m cell analysis assuming a loading of 10kPa is shown in Figure 12. In general, except for two 50m cells on the northern slope, the analyses indicate similar areas with low FoS.

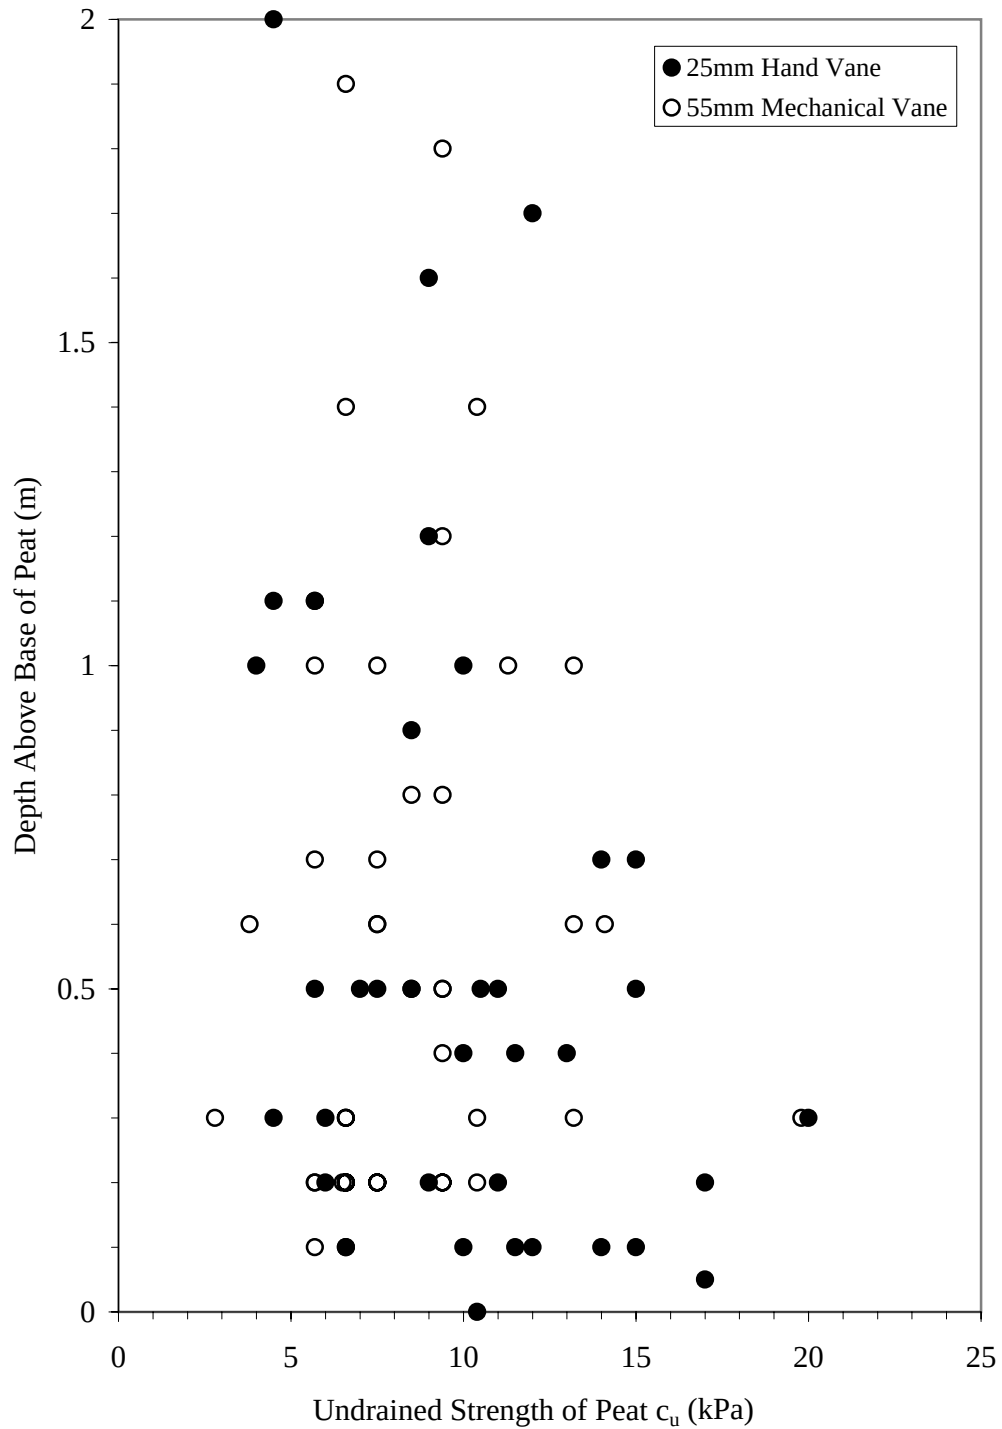
Figure 13 Variation of Undrained Shear Strength ( $c_u$ ) of Peat with Depth above Base of Peat from Vane Results

An assessment of vane test results in peat with depth was carried out to determine whether a weaker zone was present at depth. Figure 13 shows the depths of the measured vane shear strength relative to the depth of the peat/mineral soil interface (also see Appendix E). It can be seen that the investigation has not identified any widespread zone of weaker peat (strength less than 4kPa) near this interface. However, in some areas shear vane tests were not near the interface, and the presence of a weak zone cannot be precluded on a site covering such a large area. The consequence of such a weak zone would be a reduction in the FoS within the cell in question.

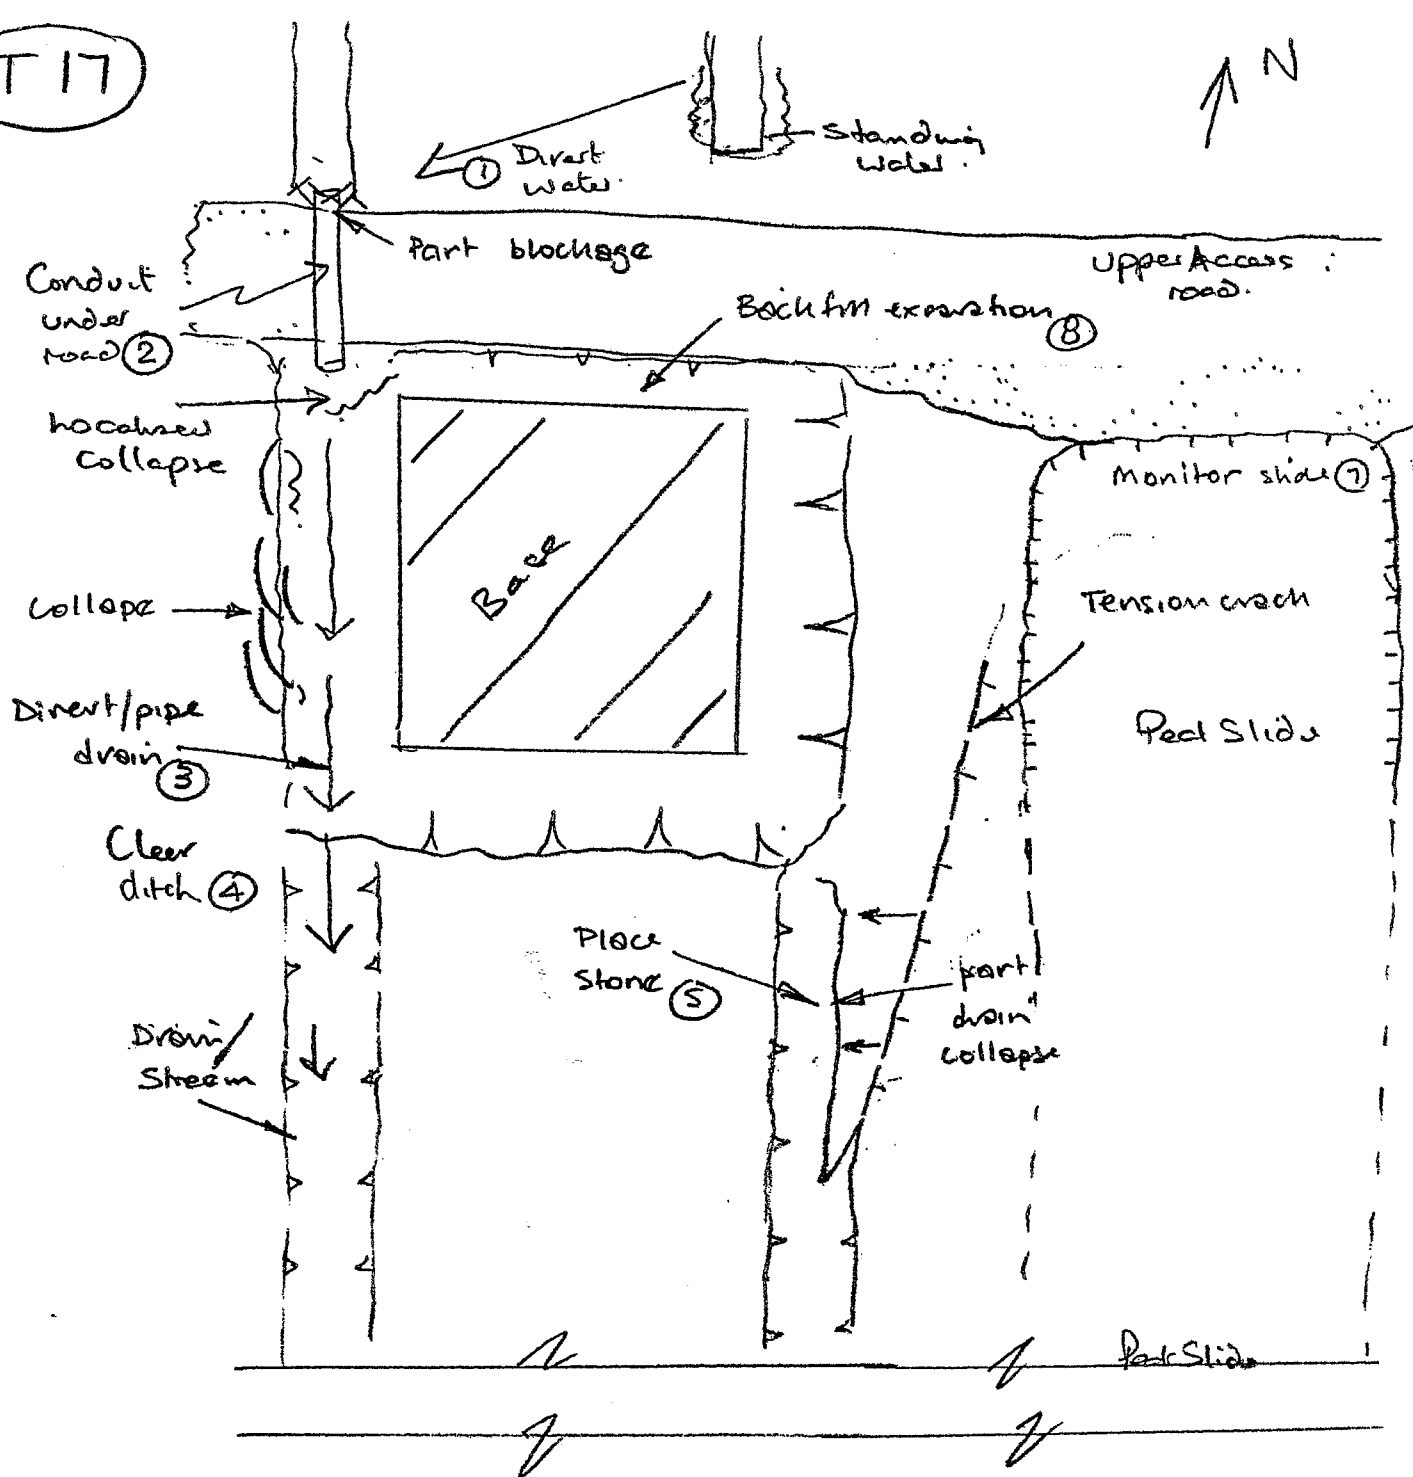
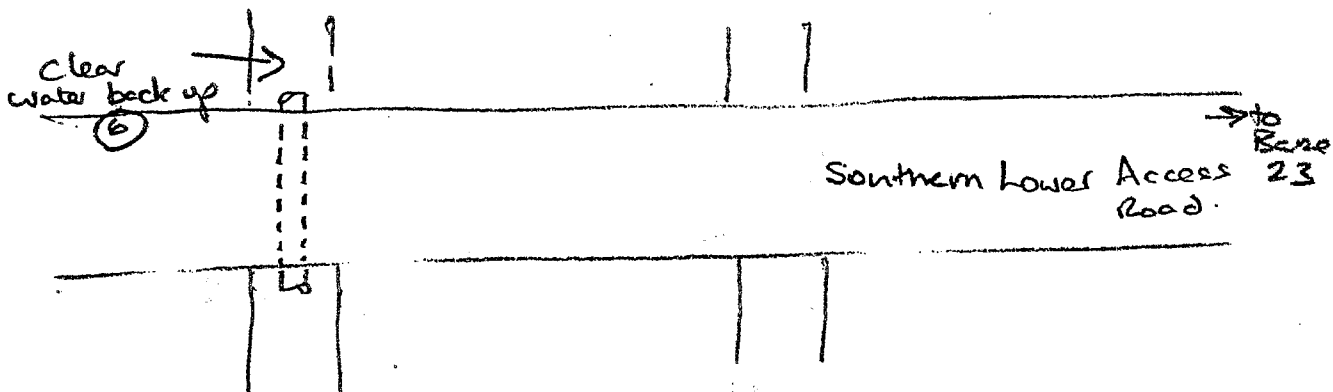
T 17

**T17 - East of Turbine Base Looking Downslope of Failure.**
